2017 Performance and Progress Report

State of Idaho Nonpoint Source Management Program

State of Idaho
Department of Environmental Quality
April 2018

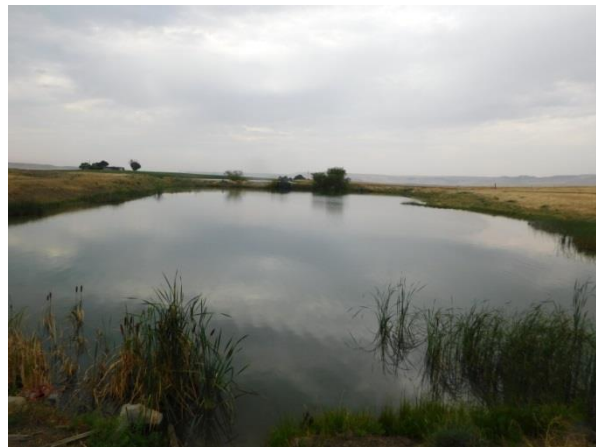
A view of the upper storage pond.

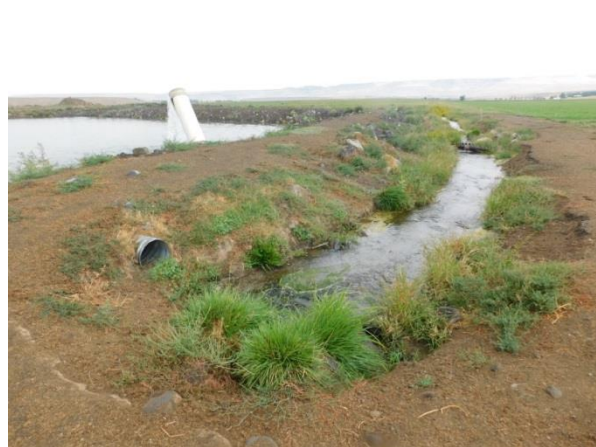
Irrigation return flows discharge from a large poly pipe into a storage pond. The storage ponds help recharge the ground water table and the Y9 ditch brings water to lower pastures.

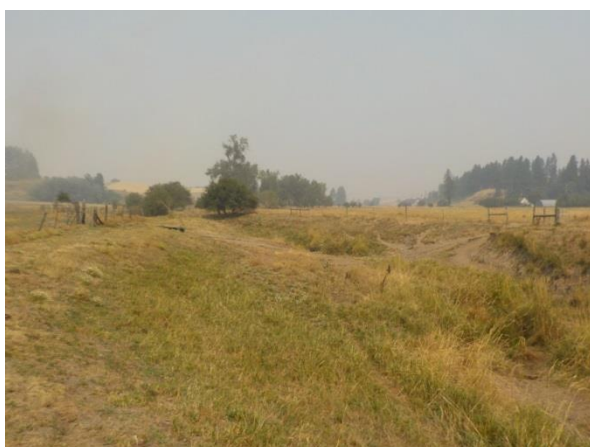
Some of the vegetation in the riparian area had been grazed.

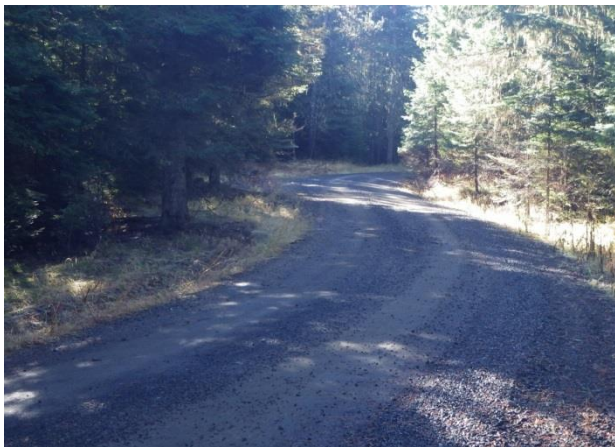
The surface of Soldier Creek Road remains in good condition, and the adjacent ditches are well vegetated.

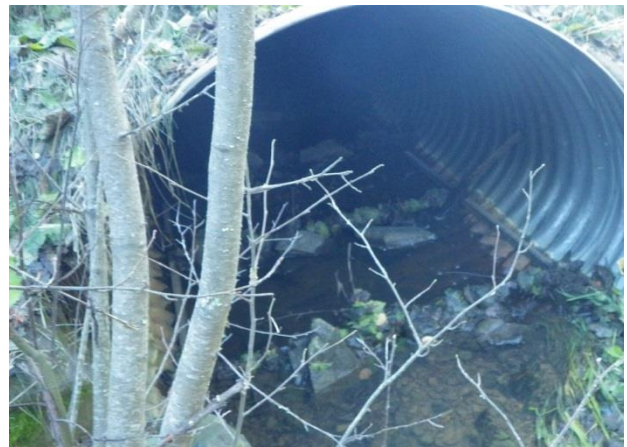
A man-made rock ladder constructed in a culvert on a tributary to Soldier Creek allows fish to migrate upstream.

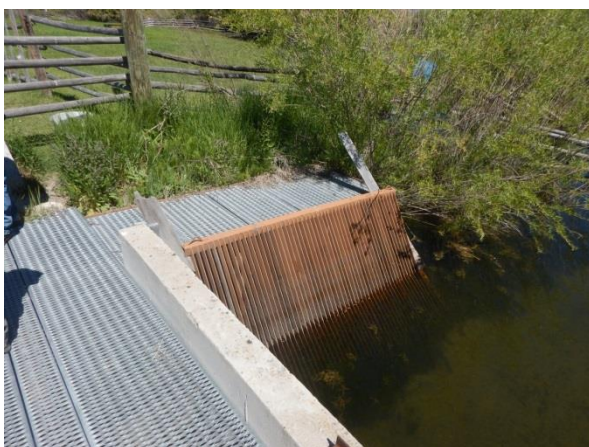
A trash rack keeps large debris from entering the fish ladder.

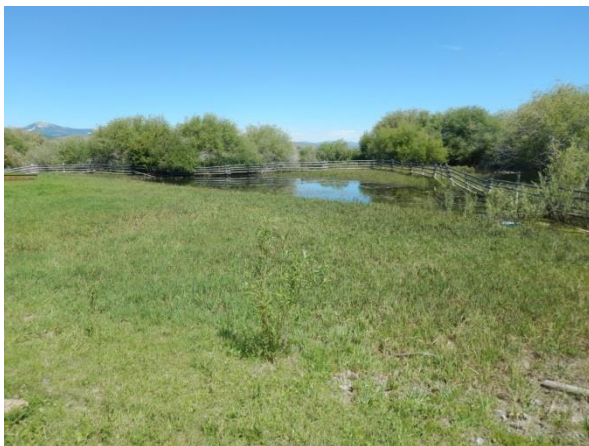
A fence installed along a stretch of St. Charles Creek limits livestock access. Willows are reestablishing themselves in the riparian area and protect the streambank from further eroding. Older, more established willows were observed at the site, easily identifiable by the mushroom-shaped crown that occurs after livestock have foraged on the new growth branches near the base.

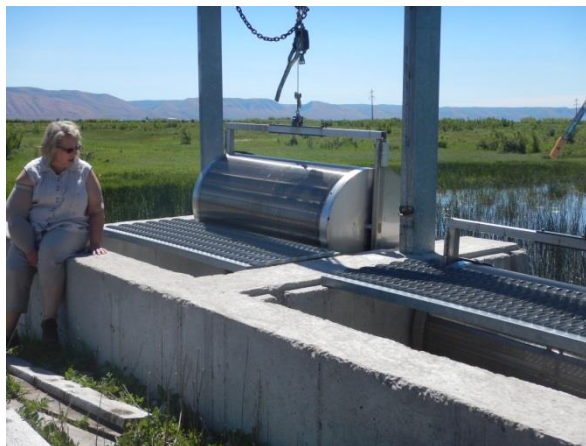
Some fish screens were installed to prevent fish from being diverted to irrigated meadows. Boards can be placed in slots in the cement to control the rate at which water leaves the meadow, thereby limiting the erosion that might otherwise occur if the water was not able to be managed.

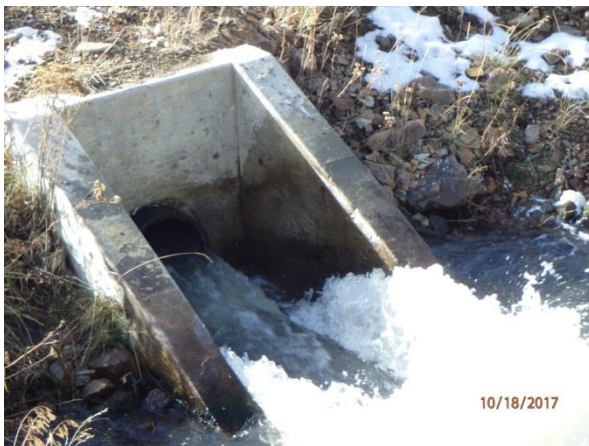
The culvert was replaced and is functioning as intended.

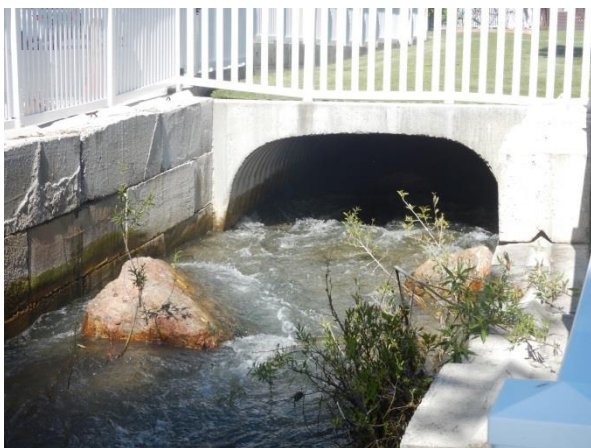
The new fish-friendly bottomless culvert allows fish to migrate up Fish Haven Creek to spawn. Boulders were placed in the channel to decrease the velocity of the water exiting the culvert and to prevent erosion from occurring further downstream in the channel.

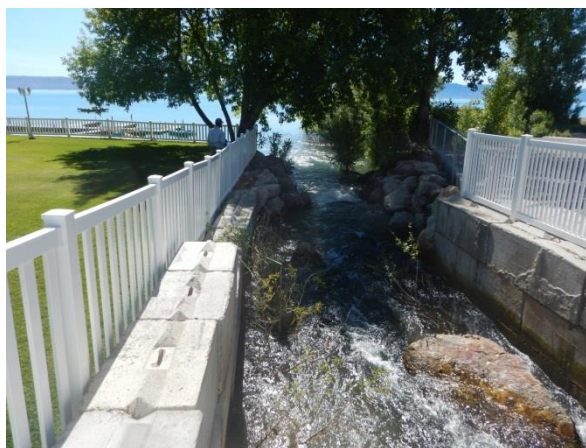
Water from the culvert eventually flows into Bear Lake. Some large head cuts were observed in this section of the creek.

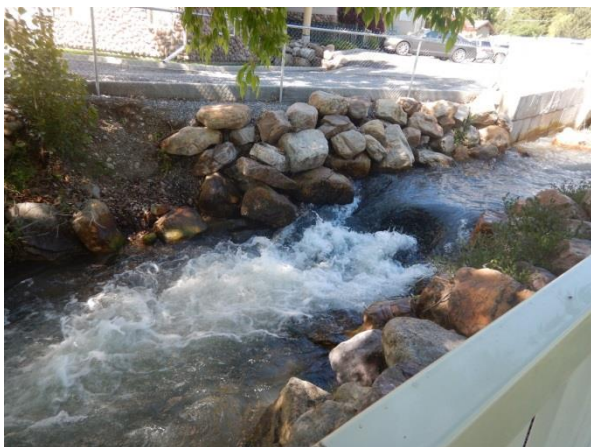
Large rock was placed along the shoreline at this section of the creek to protect a sewer line that crosses under the channel. In the past, the channel bed was scoured and eroded to the point of exposing the line at the bottom of the channel, making it vulnerable to damage and breaking. A drinking water line that crossed under the channel was also exposed for a short time before the project manager restored the stream grade to protect the line.

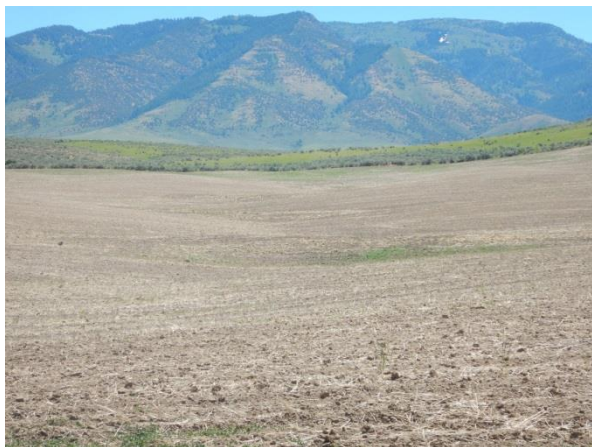
The four sediment basins that were excavated in this field serve to reduce the energy level of the runoff. Before the basins were built, water running off of the field would create a large gully further down the drainage.

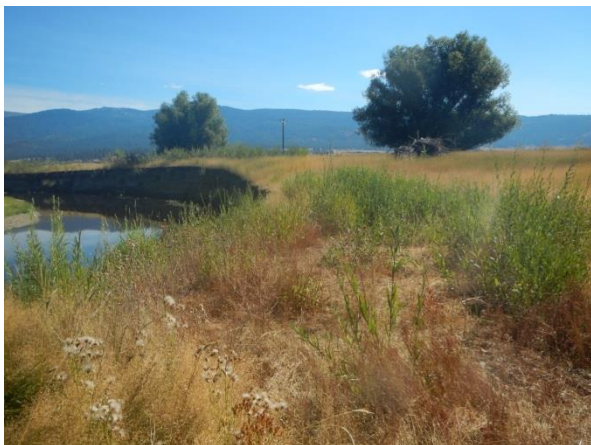
Since 2015 when this site was last planted, evidence exists of elk, deer, and bear grazing in the area. Little plant growth was evident because much of the ground cover had been heavily trampled. This property is in the 15th year of a 30-year contract with the Natural Resources Conservation Service (NRCS) under its Wetland Reserve Program. With NRCS approval, IDFG may be allowed to return to the area with the T-posts needed to protect cottonwoods.

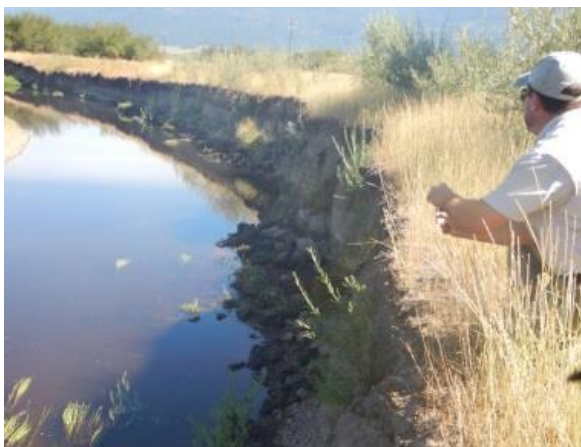
Reed canary grass, which has inundated the area, provides some stabilization but is not ideal for soils that may see higher flows. The willows in this photograph are strong suckering or rhizomatous species. Their roots have found their way to the bare riverbank and will provide stabilization at higher flows.

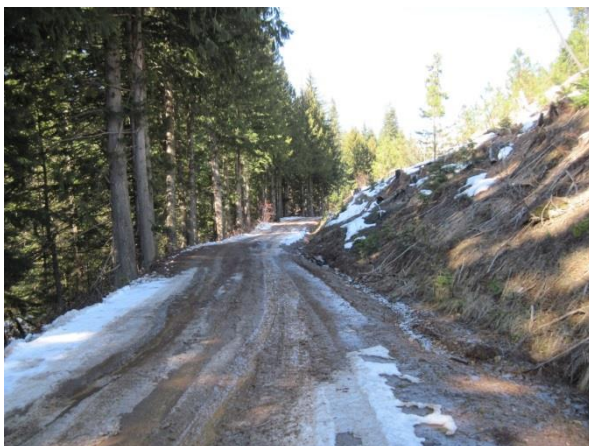
Before project implementation, Alder Creek Road was in poor condition.

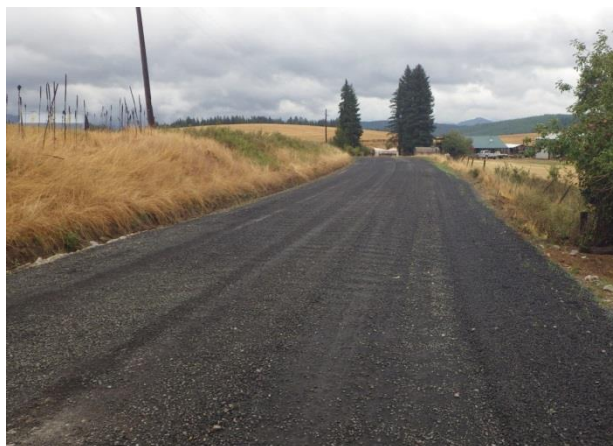
The project included resurfacing and widening the road, along with installing new or replacement culverts.

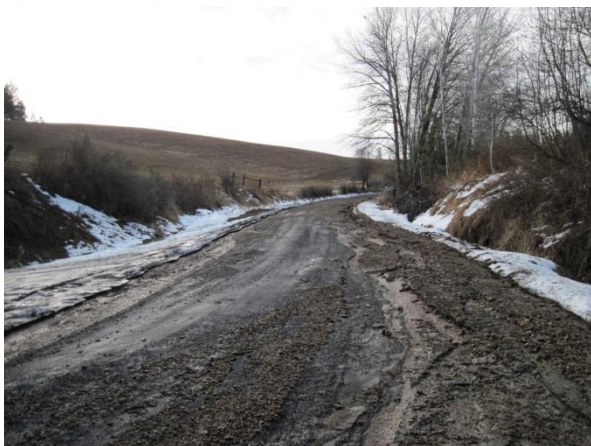
Before starting the project, Bloomsburg Road was in poor condition. Problems with drainage and erosion resulted in significant amounts of sediment deposited in the lake.

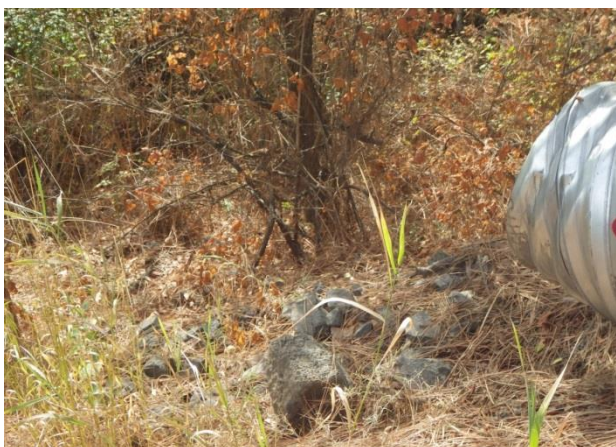
This relief culvert with rock armoring below the outlet was installed as part of the project.

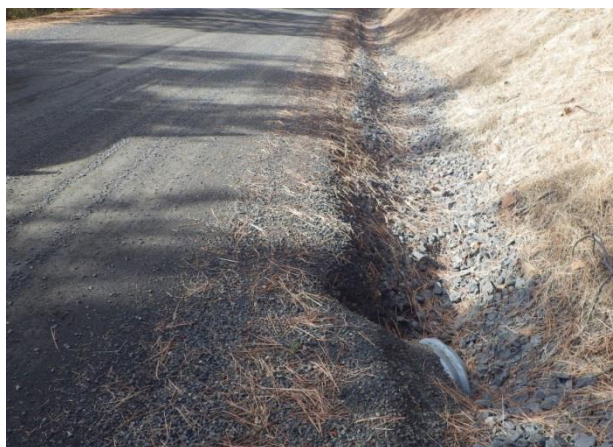
To reduce erosion, the Worley Highway District lined the drainage ditches along the road with rock.

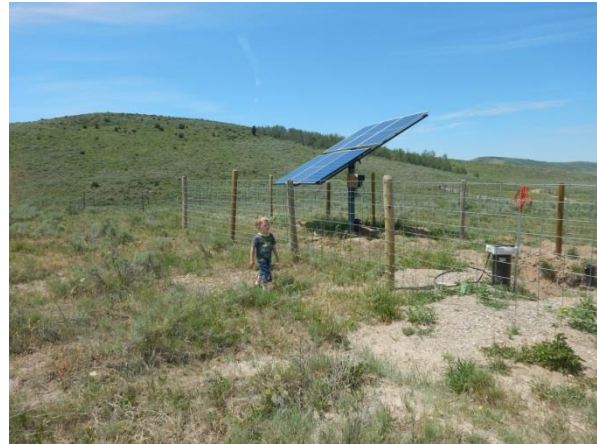
A solar pump draws water from a well to a storage tank to create an off-stream water source for livestock. Providing alternate sources of water help to keep livestock from damaging banks and channels while watering in the stream.

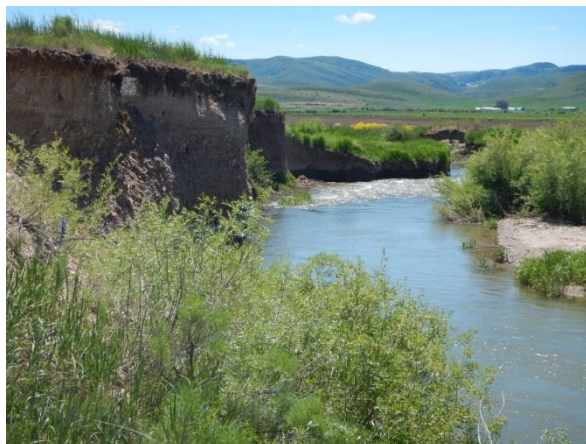
The district intends to develop a plan to reduce the high level of erosion that occurs along this bank. The stream currently undercuts the bank causing large areas of soil to collapse into the stream. The plan calls for installing large rock along the toe of the bank and barbs or J hooks to relieve the lateral pressure on the bank.

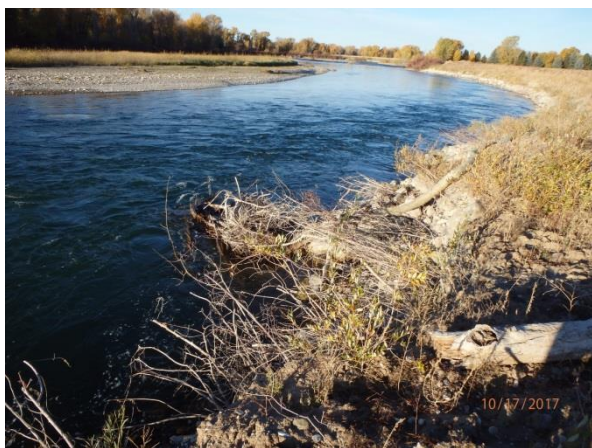
Five water-deflecting weirs were installed, each consisting of large rock and a 70-foot length of cottonwood tree, complete with its root wad protruding from the bank. The toe of one weir has started to degrade due to high flows. Willow and cottonwood trees and grasses were planted throughout the project site. The vegetation is well established and growing, without the use of applied irrigation. The bank was beveled back with benches created at different heights to make areas for additional rock and woody reinforcement to be placed, as needed.

One rock weir has been undercut and is degrading as a result of high flows.

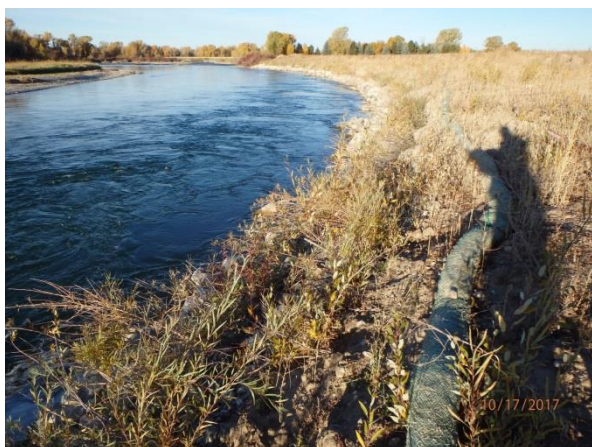
The bank in the project stretch was beveled back and benches were constructed at different heights to provide more area to place additional rock and woody reinforcement, if necessary.

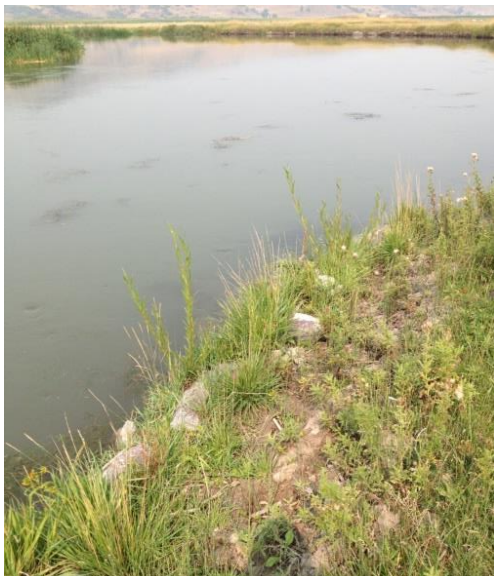
Toe rock was placed along the streambank to help keep the bank from further eroding while the new vegetation is getting established. Willows can be seen growing among the rocks.
